NYS Home Inspector

Inspection Report

Property Address:

212 grand
bronx NY 12345

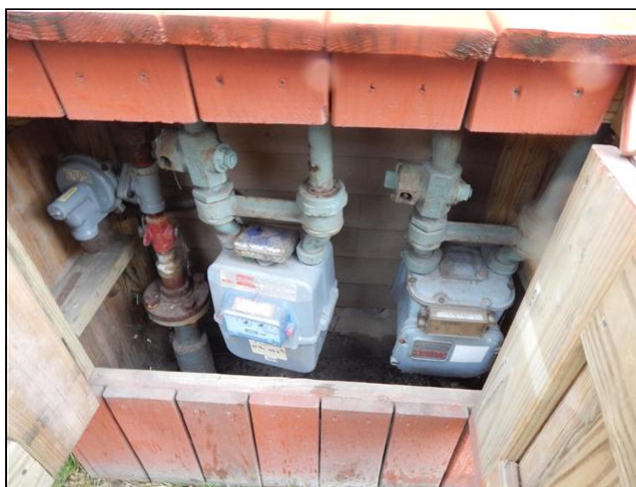
1.0 Item 1(Picture)

1.0 1. For one family CO, there is two gas meters.

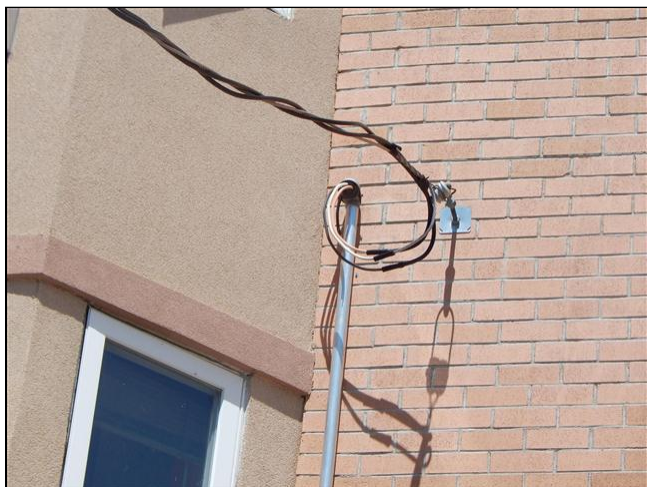
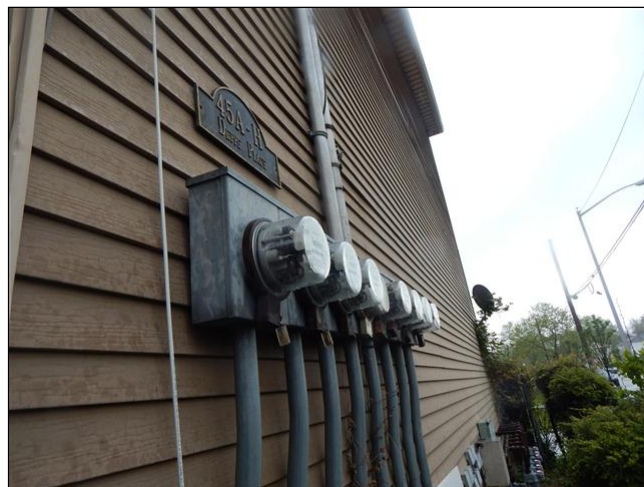
1.1 Item 1(Picture)

1.1 4. For one family CO, there is two electrical meters.

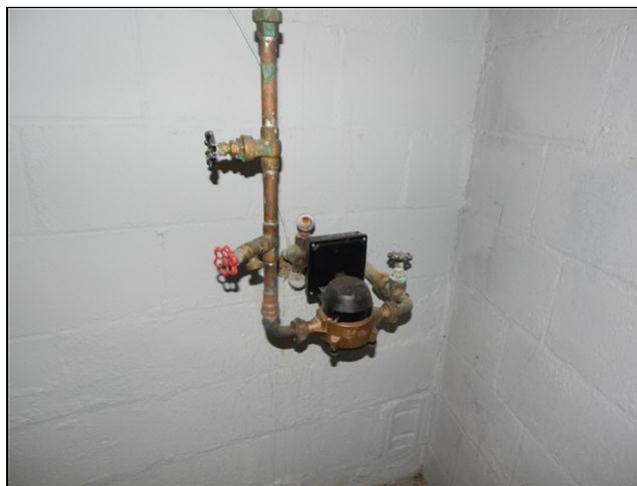
1.2 Item 1(Picture)

1.2 (1)) The water meter is in good condition. All the following items are attached.

- a) water meter
- b) emergency shut off valve
- c) electrical ground

1.2 (2) Low water pressure

Home water supply pressure was lower than the 40 pounds per square inch (PSI) considered adequate by generally-accepted current standards. The Inspector recommends service by a qualified plumbing contractor.

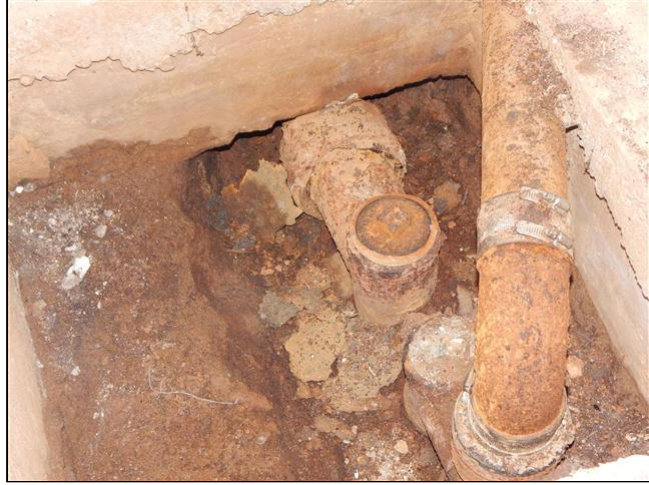
1.3 Item 1(Picture)

1.3 . The main sewer clean out seems to be in good condition

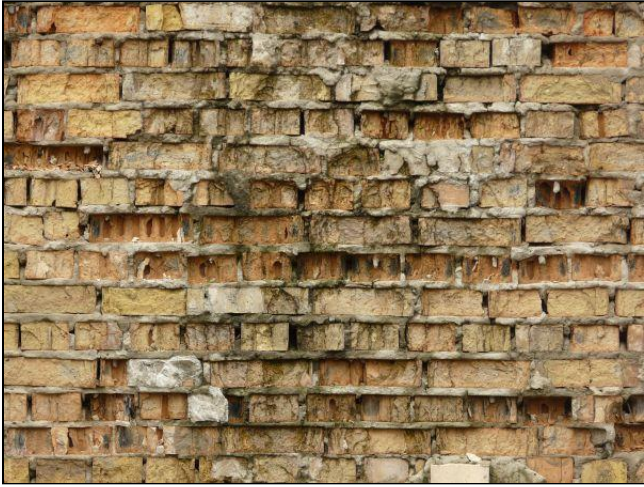
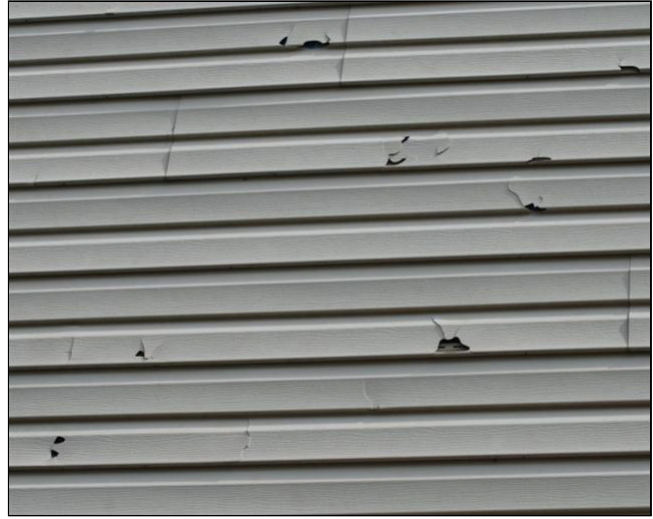
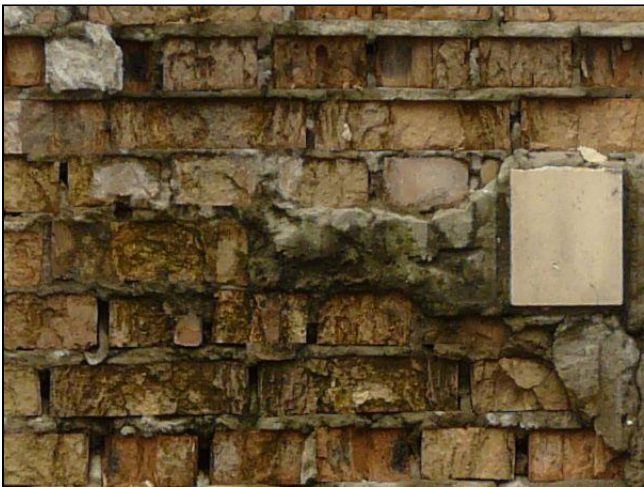
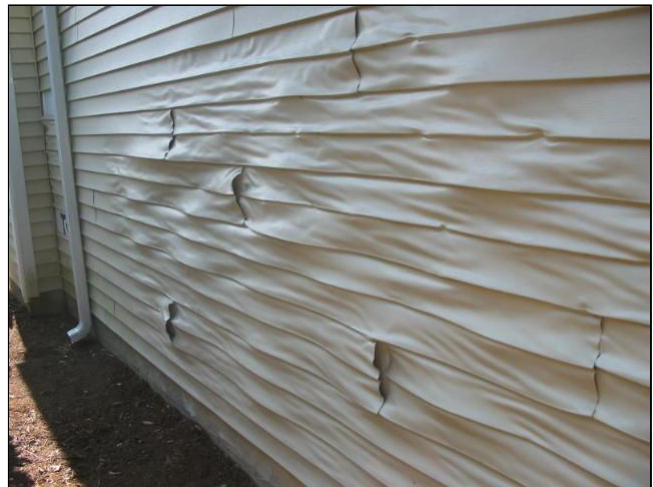
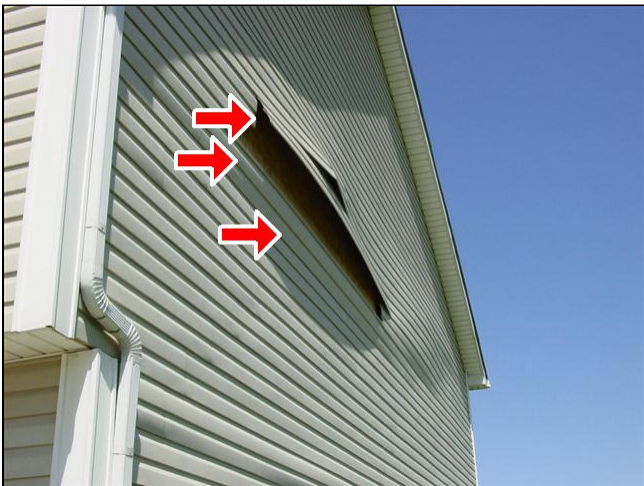
2.0 Item 1(Picture)

The brick exterior walls were not flat and straight but various portions bowed in and out. This indicates that metal fasteners designed to secure the brick to the underlying substrate have failed. This is not uncommon in older homes as metal fasteners fail due to corrosion. The Inspector recommends that before the expiration of your Inspection Objection Deadline you consult with a qualified masonry contractor to gain an idea of options and costs for correction or stabilization, which may be relatively expensi

2. Severe surface deterioration (weathering)

Brick exterior walls had severe general surface deterioration which appeared to be the result of long-term weathering. The Inspector recommends that before the expiration

3. Severe damage to vinyl

Vinyl siding covering exterior walls had areas of severe damage which should be repaired to avoid future problems such as moisture intrusion. Moisture intrusion may cause internal wall structural or material damage and/or create conditions favorable to the growth of potential biological health hazards such as mold fungus.

The vinyl siding covering exterior walls had holes which should be repaired, or siding sections replaced to prevent moisture intrusion of the wall assembly.

Moisture intrusion can damage materials and encourage the growth of microbes such as mold fungi. Excessive growth of mold fungi can produce high concentrations of mold spores in indoor air which can cause serious health problems in some people.

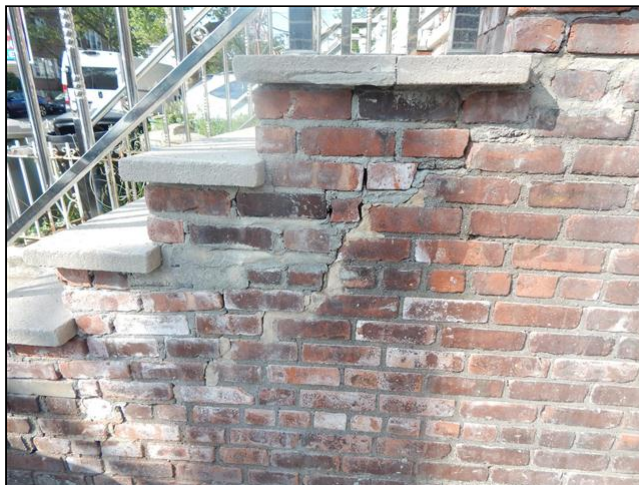
2.3 Item 1(Picture)

2.3 Cracked or damaged brick

brick(s) at the exterior stairway were cracked or damaged and needed repair at the time of the inspection. This condition is a potential trip hazard. All corrections should be made by a qualified contractor.

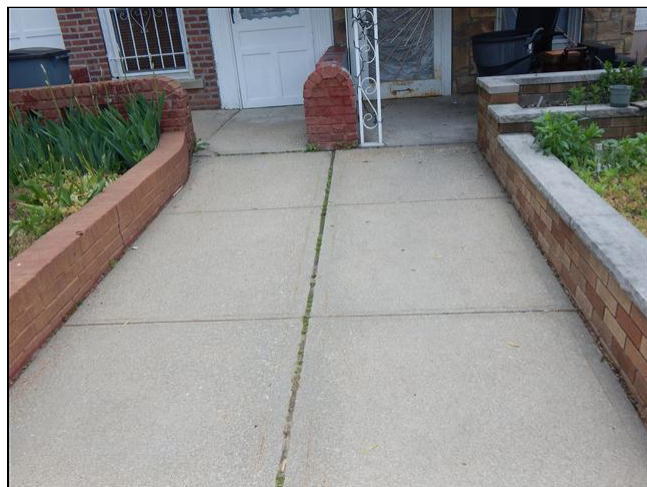
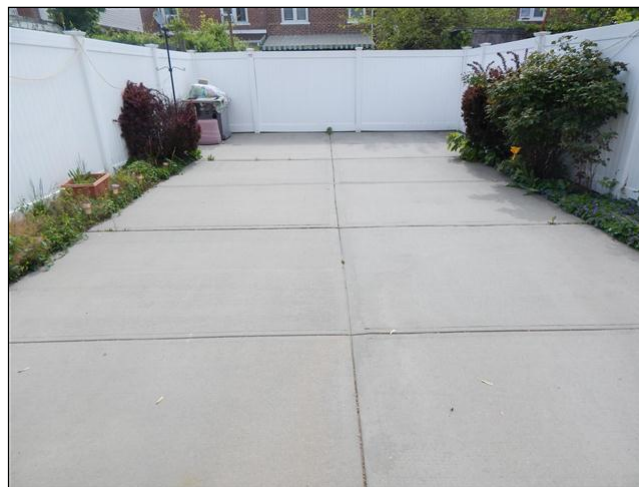
2.4 Item 1(Picture)

2.4 DRIVEWAY CONDITION

The driveway appeared to be in generally serviceable condition at the time of the inspection. Notable exceptions will be listed in this report.

Walkways OK

Home walkways appeared to be in serviceable condition at the time of the inspection.

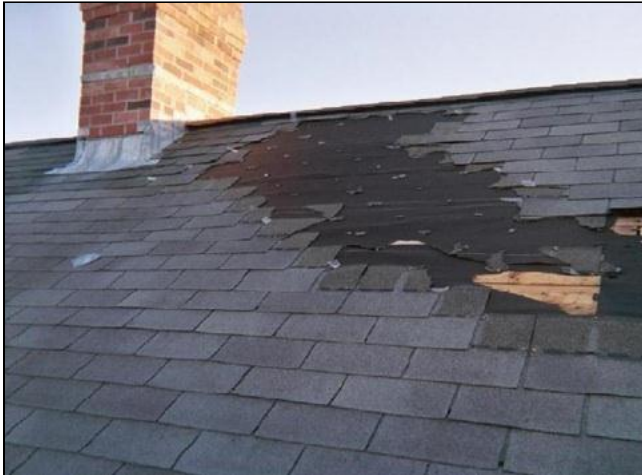
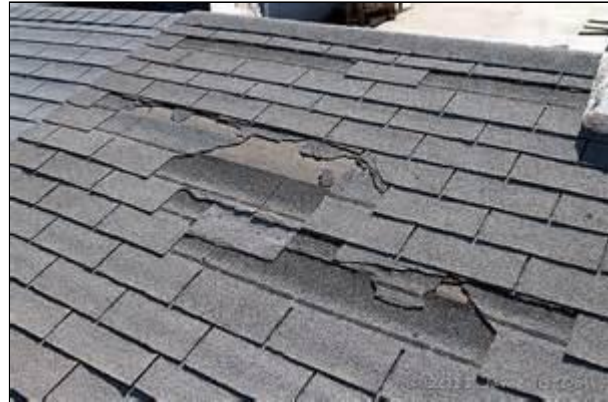
3.0 Item 1(Picture)

3.0 Severe deterioration (end of life)

Asphalt composition shingles covering the roof of this home appeared to be at or near the end of their long-term service life.

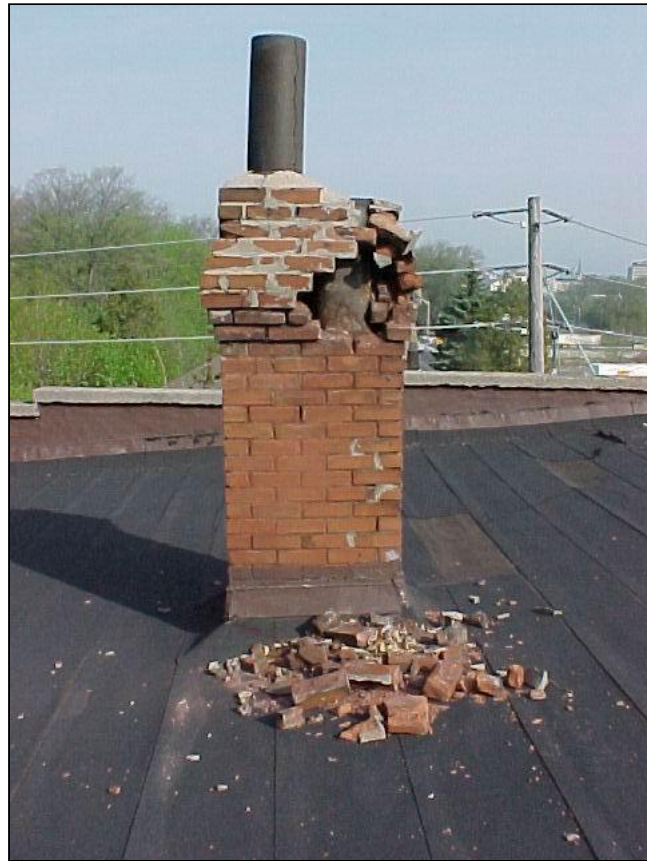
3.2 Item 1(Picture)

3.2 (1) Loose bricks

The chimney had bricks which were loose at the time of the inspection.

Falling bricks may cause injury or death.

The Inspector recommends correction by a qualified masonry contractor.

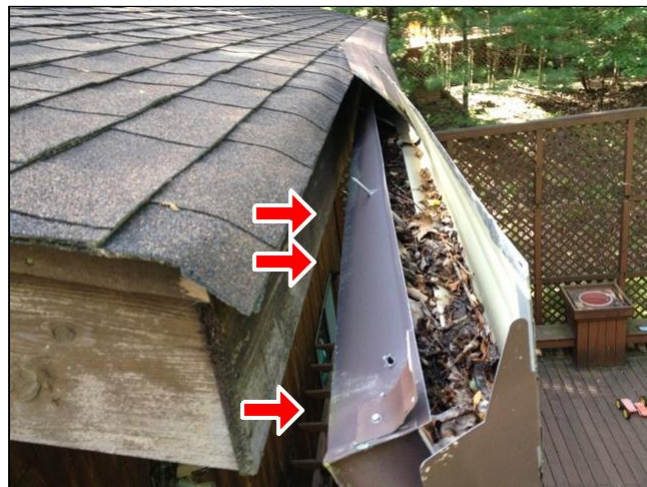
3.3 Item 1(Picture)

3.3 Loose gutters

Gutters were loose in some areas and should be refastened by a qualified contractor.

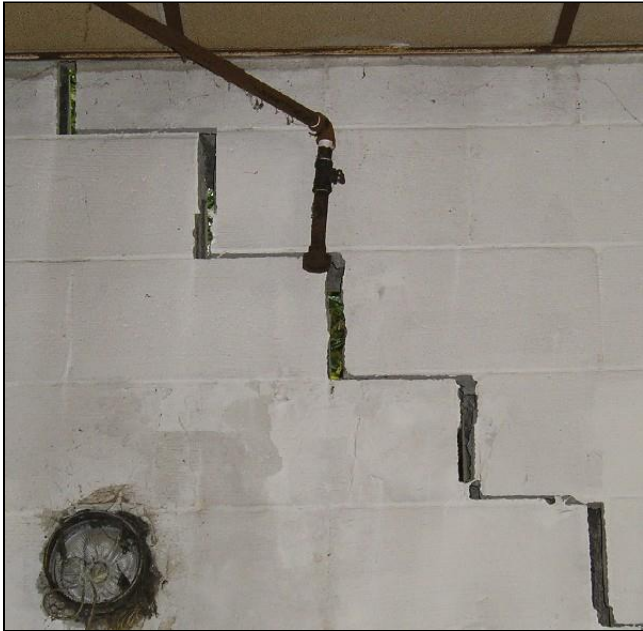
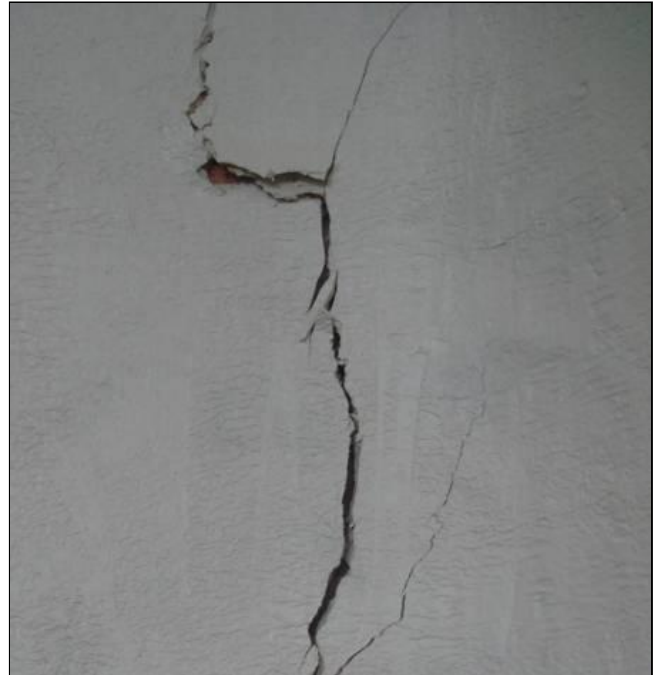
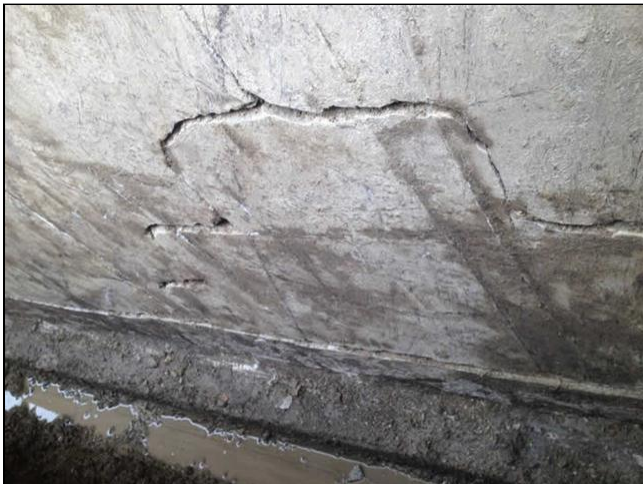
5.1 Item 1(Picture)

5.1 Cracks (heaving)

Cracks visible in the poured concrete foundation walls were consistent with damage caused by soil heaving. This type of damage is consistent with damage caused by expansive soils.

Expansive soils are soils which increase to many times their original volume in response to increases in soil moisture content. This increase in volume (expansion) creates a force which can easily damage foundations.

You may wish to have this condition evaluated by a structural engineer to determine the cause of cracking and the likelihood of continued damage and to discuss options and costs for stabilization.

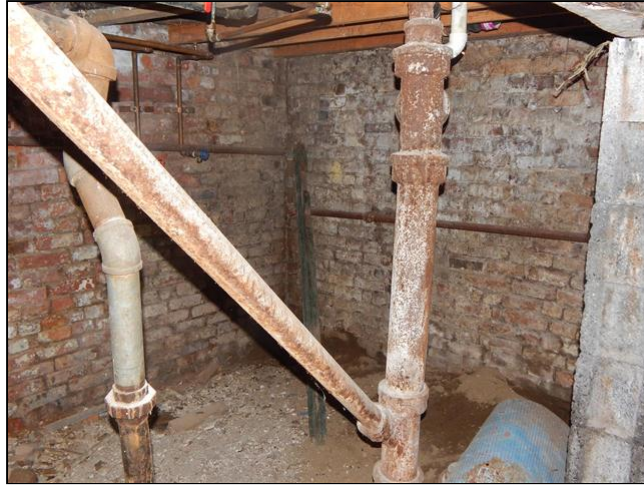
6.0 Item 1(Picture)

6.0 The sewer pipe has been found deteriorate with age and rusty . Cracks and breaks can be predicted in the near future. It is recommended to replace a new sewer pipe for better sewerage.

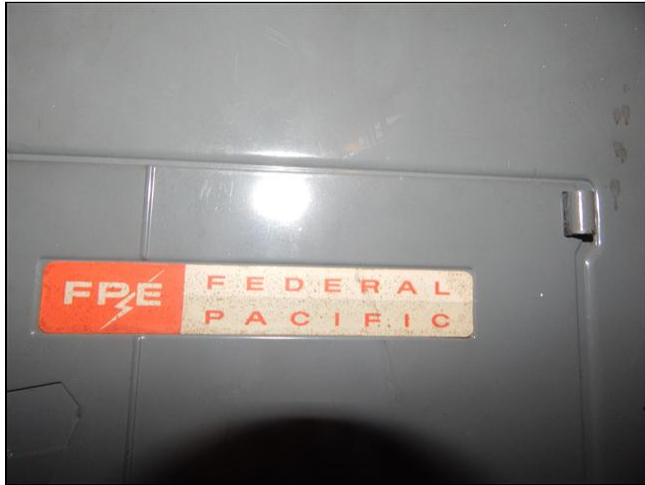
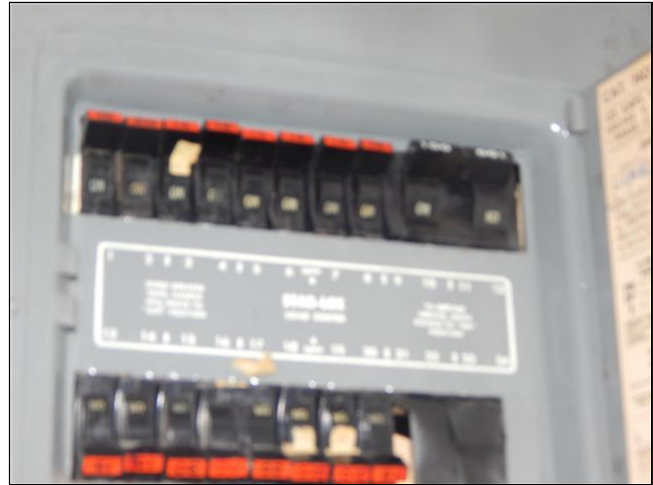
7.1 Item 1(Picture)

7.1 Federal Pacific Panels

Federal Pacific Stab-Lok style breakers were found. While this type of breaker was commonly used during the time period of installation, these breakers have been found to sometimes not trip or disconnect when required. This could cause the breakers or wire to overheat thereby creating a potential safety or fire hazard. We recommend that you have a licensed electrician change the panel box and type of breakers used to prevent injury or fire damage.

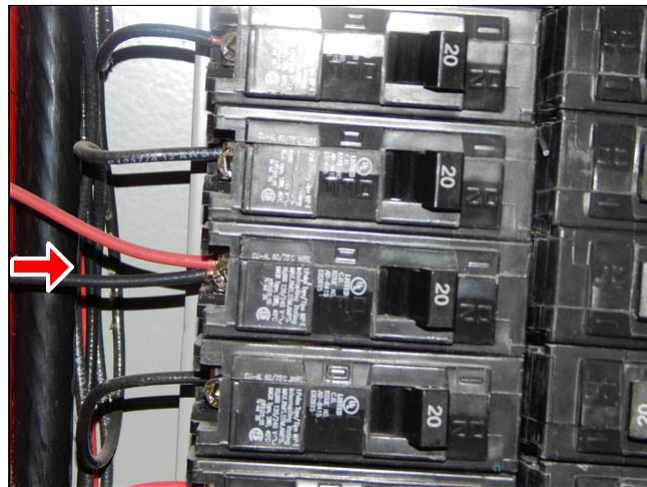
7.2 Item 1(Picture)

7.2 1. Interior electrical wiring is 60% outdated and some is using aluminum and we highly recommend upgrade to copper wiring to prevent fires and electrical shortage. Ask qualified contractor for the estimate price.

2. Double-tap

In the sub-panel, branch conductors were connected to a breaker designed for only one conductor. This is known as a "double-tap" and is a defective condition which should be corrected by a qualified electrical contractor.

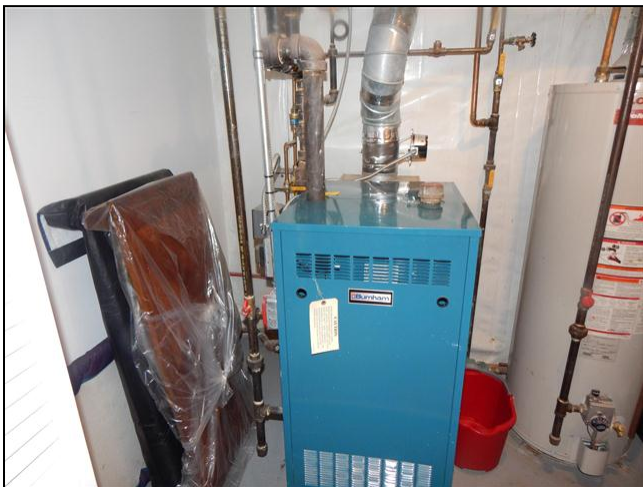
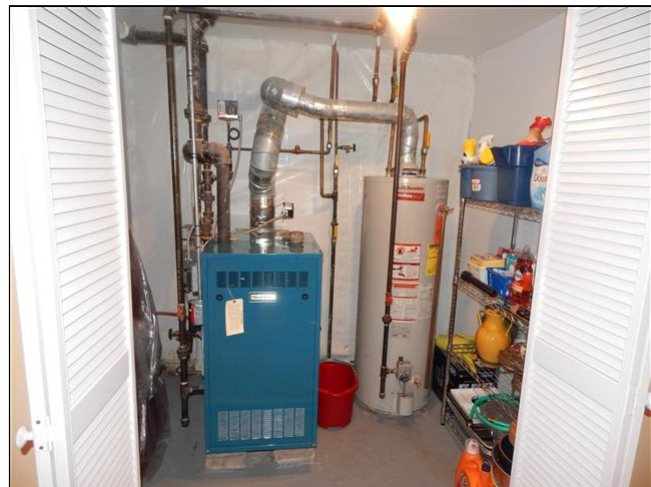
8.0 Item 1(Picture)

The boiler supplied heat upon demand and most boiler components appeared to be in serviceable condition at the time of the inspection. Notable exceptions will be listed in this report.

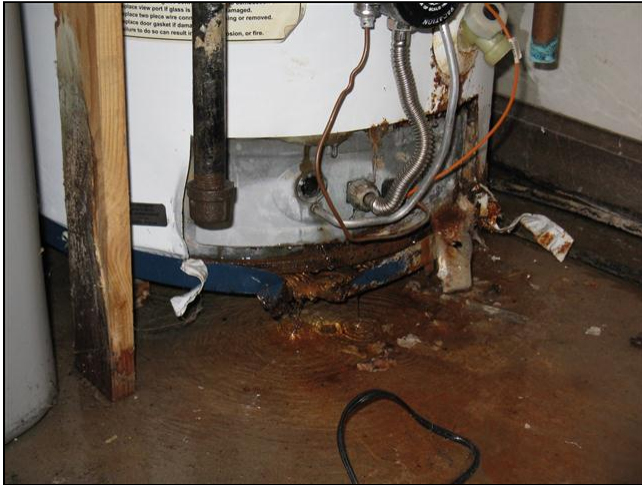
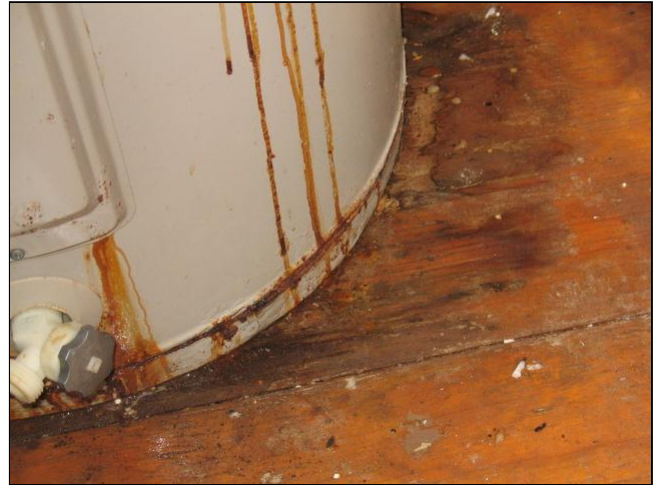
8.4 Item 1(Picture)

8.4 1. Past design life

The hot water tank was old, past its design life, and may need replacement soon. It appeared to be within safe pressure and temperature limits at the time of the inspection.

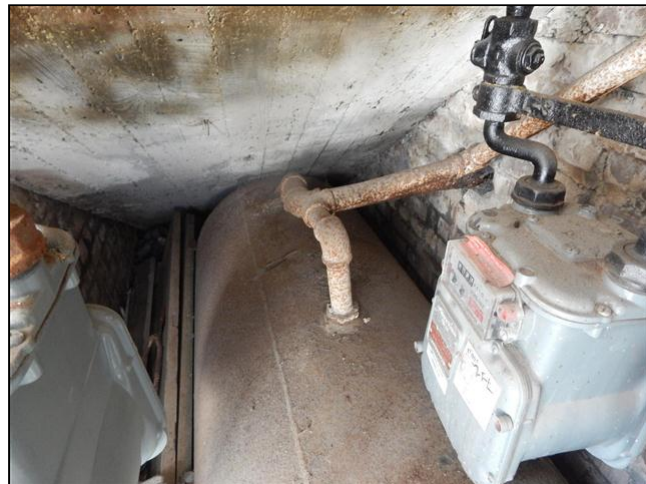
8.6 Item 1(Picture)

8.6 We notice the oil tank is still in premise while the unit has been converted to gas. By law, the oil tank needs to be removed. We notice there is an old oil tank underground. We recommend it be removed.

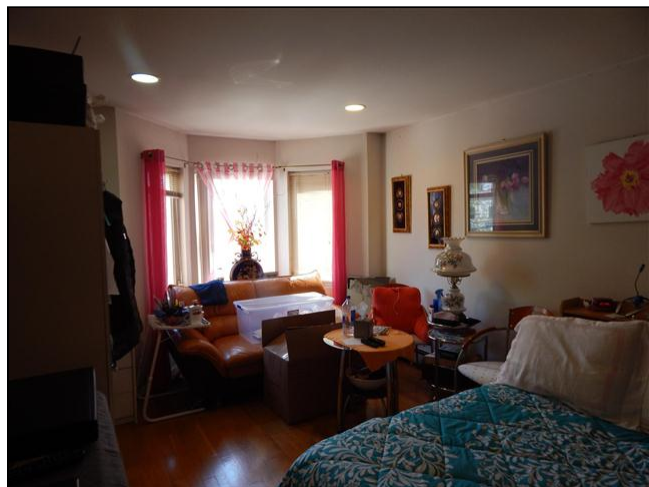
10.0 Item 1(Picture)

INTERIOR TRIM

- Door casing
- Window casing, sashes and sills (condition and proper operation)
- Baseboard
- Molding (crown, wainscot, chair rail, etc.)

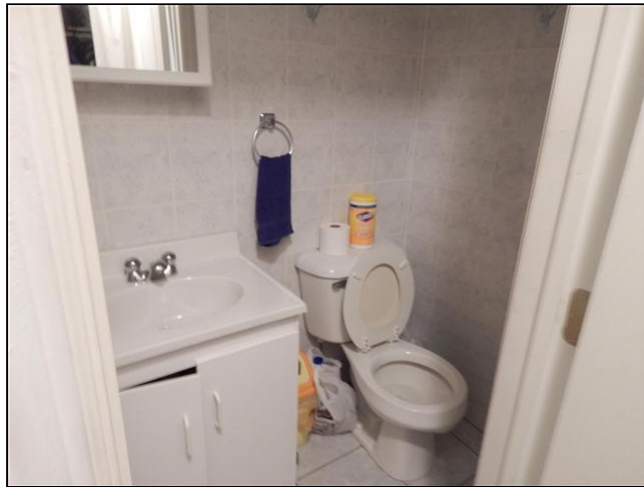
12.0 Item 1(Picture)

-Wall, ceiling and floor condition

-Moisture meter survey for moisture trapped beneath vinyl or tile floor coverings around toilets, tubs and showers.

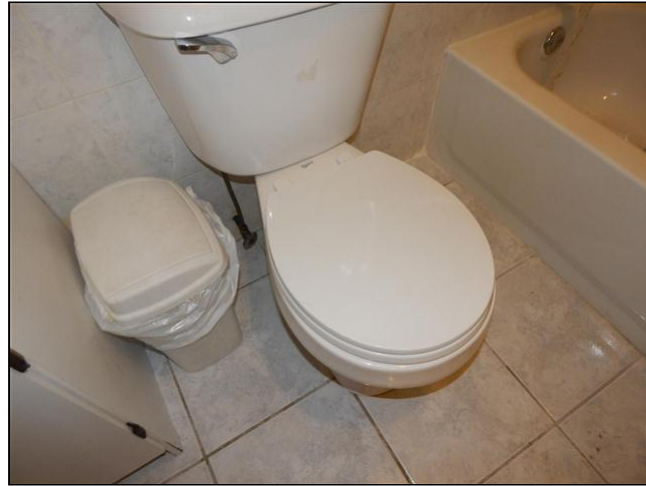
12.1 Item 1(Picture)

12.1 Faucet was loose

The bathroom sink faucet was loose and should be mounted more securely.

Loose at floor

The toilet was loose at the floor and should be re-attached by a qualified plumbing contractor.

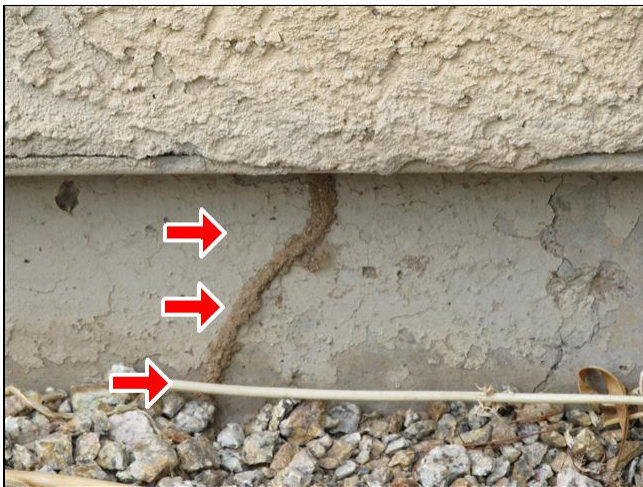
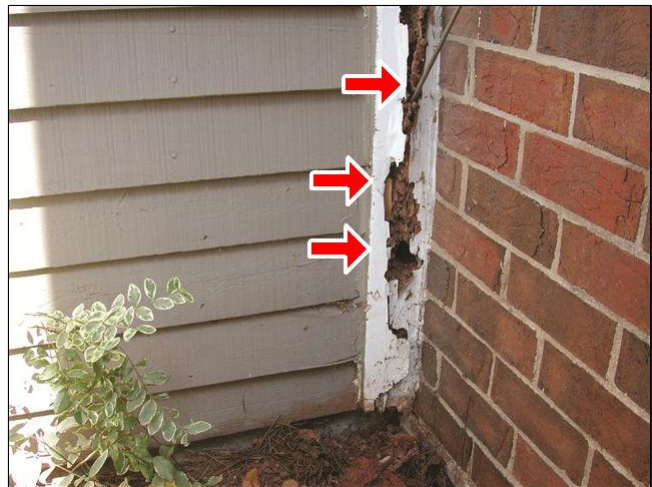
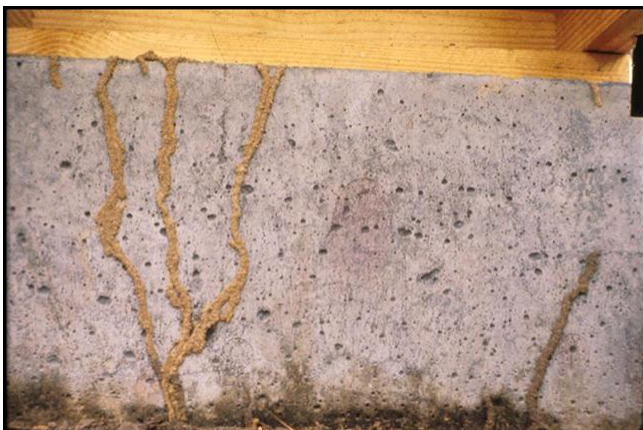
13.0 Item 1(Picture)

13.0 1. termite damage

The home interior had signs indicating a termites infestation which should be addressed. The Inspector recommends that you contact a pest control service.

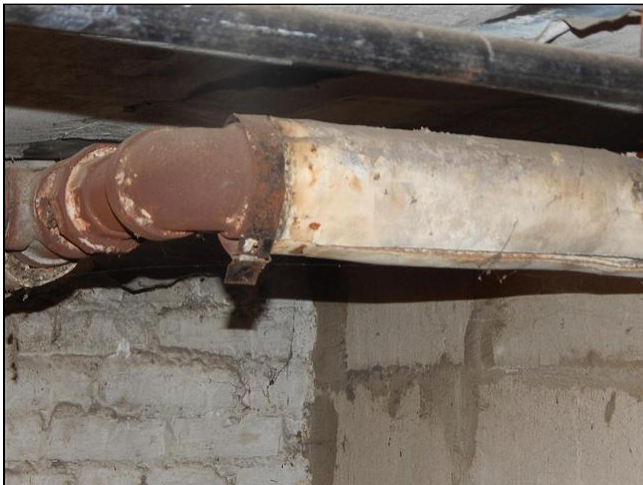
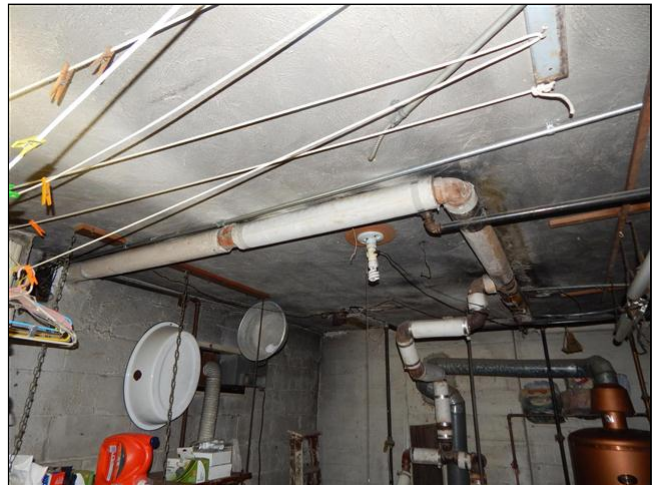
13.2 Item 1(Picture)

In its friable form (in which fibers may be released into the air and inhaled) asbestos is a known carcinogen and a cause of asbestosis. Confirming the presence of asbestos requires testing by a qualified laboratory.

Consider consulting with a qualified asbestos abatement contractor to discuss options and costs.
